# **DAMAGE TO ANDAMAN & NICOBAR ISLANDS DUE TO EARTHQUAKE AND TSUNAMI OF DEC. 26, 2004**

**D.K. Paul, Yogendra Singh and R.N. Dubey**

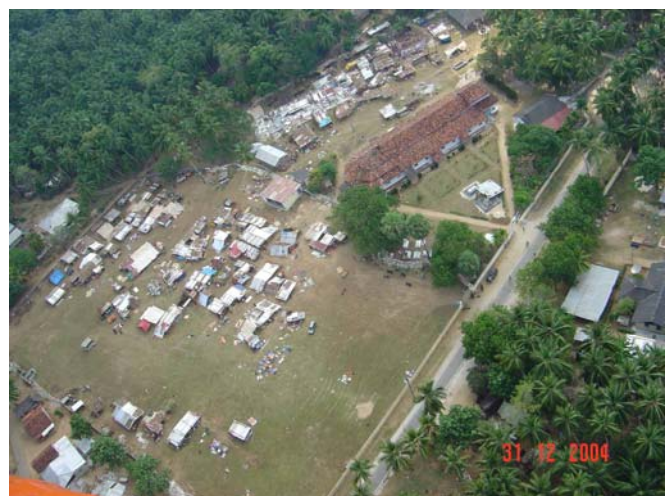
*Fig. 1 Arial view of damage in Port Blair*

Figure 1 shows an Arial view of earthquake damage to buildings. Two types of building constructions have been prevalent in Andaman and Nicobar islands: (i) Buildings with load bearing walls of concrete block masonry and sloping tiled or sheet roofs, and (ii) RC frame buildings. Buildings have suffered damage due to ground shaking, as well as due to tsunami waves. The buildings near the coasts have suffered more damage, compared to those away from the coast, due to the following reasons:

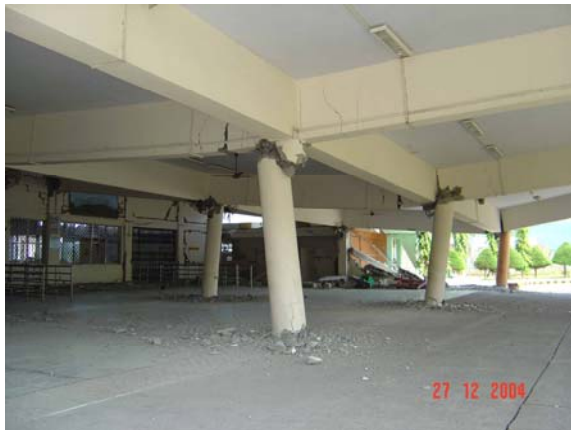
**Fig. 2 - Damaged Passenger hall Building at Haddo Wharf, Port Blair, Andaman Island**

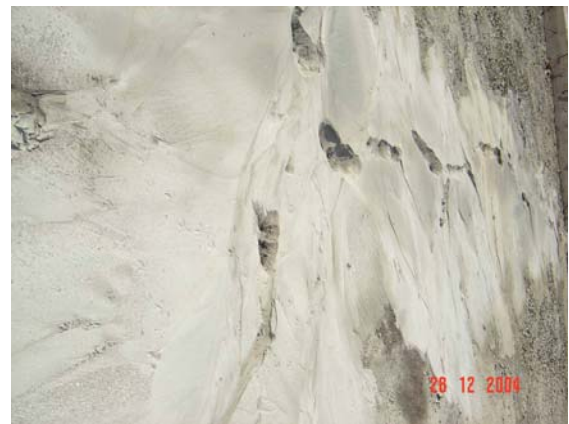
**Fig. 3 - Liquefaction at Haddo Wharf, Port Blair, Andaman Island**

- (ii) Near the coast, the buildings have been founded either directly on the reclaimed land on isolated footings or on piles. Many buildings have more than one type of foundation systems for integrally connected super structure. The different types of foundation systems have resulted in differential settlement and damage to the superstructure. Columns having isolated footings on reclaimed land have been observed to undergo excessive settlement. Figure 2 shows the damage to Passenger hall Building at Haddo Wharf, Port Blair, Andaman Island. Due to sandy soils and high ground water table near the sea shore, liquefaction has taken place resulting in damage to the structures. Figure 3 shows the liquefaction at Haddo Wharf, Port Blair, Andaman Island.

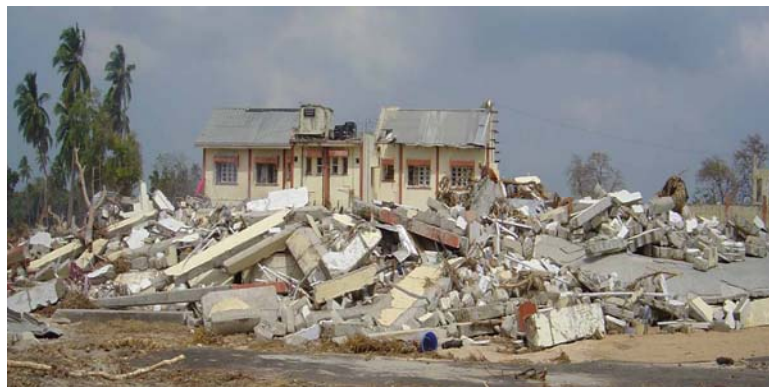
Air force station at car Nicobar had a beautiful residential colony near the sea shore. Due to their proximity to sea and low ground level, the colony buildings were subjected to the Tsunami waves. The buildings suffered damage due to ground shaking and liquefaction, and the final blow from Tsunami waves. Most of the buildings have suffered total collapse (Fig. 4) and many have been washed away by the waves. The height of the waves can be visualized by the objects put at the tree tops.

**Fig. 4 Collapse of buildings due to tsunami waves**

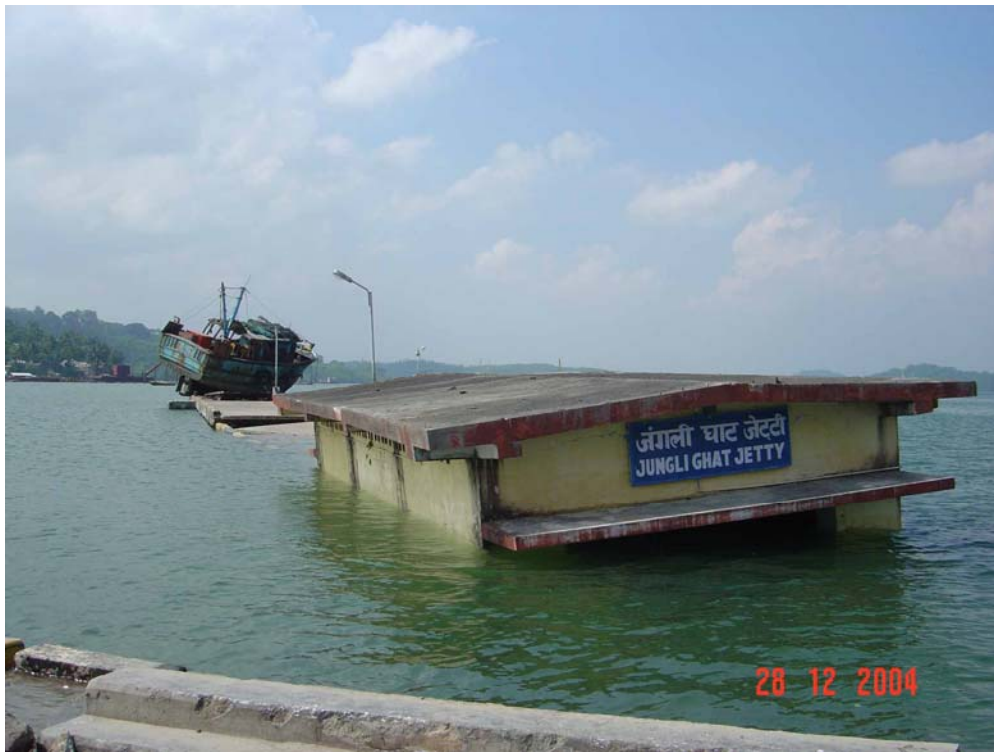
*Fig. 5 Collapsed and submerged Jungali Ghat Jetty, Port Blair, Andaman Island*

The port and harbour structures have been severely damaged. Some portion of Fisheries jetty at Phoenix Bay complex and Jungali Ghat jetty in Andaman island; jetties at Katchal and in Campbell Bay islands of Nicobar have collapsed and submerged in water. The harbour structures at Port-Blair namely, Haddo Wharf, Phoenix Bay Harbour complex, Chatham (Old and New), Hope Town and Jungali Ghat have been damaged by pounding between the berth blocks. Part of the Jungli ghat jetty was submerged as shown in Fig.5. The relative displacement between the different berth blocks has resulted in misalignment of crane rails hampering the cargo handling. The tsunami waves affected about 0.5m to 1.5 km inside the coast line. Figure 6 shows the inundation along the coast.

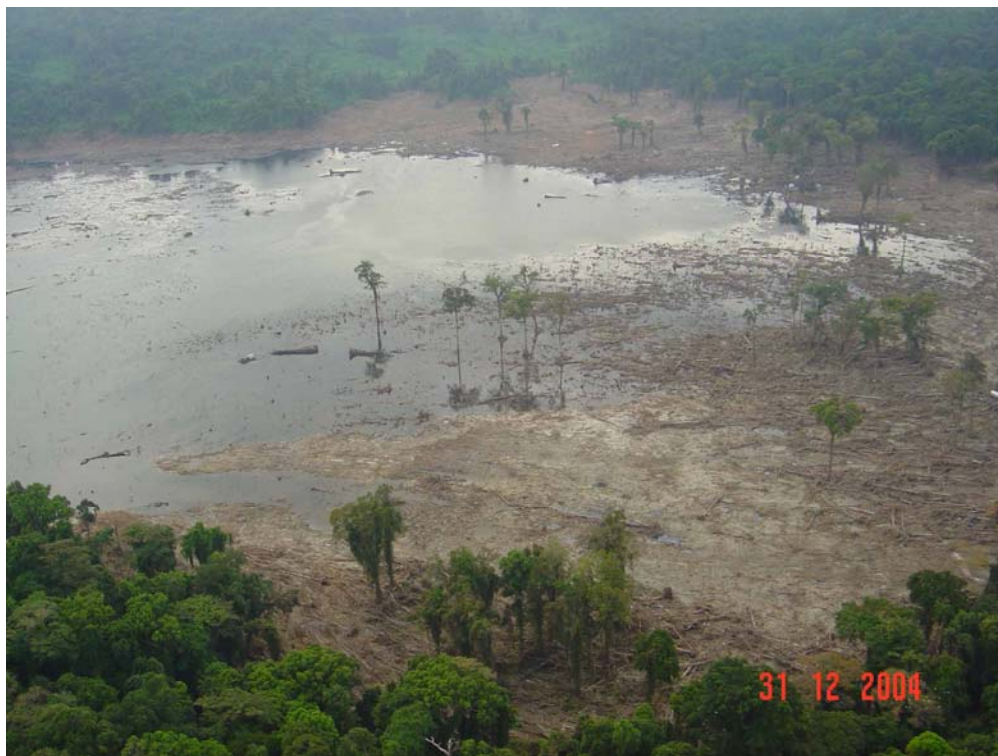
*Fig. 6 - An ariel view of tsunami inundation in Car Nicobar*
